EVALUATION OF 100 MM BORE BEARINGS AFTER
ACCELERATED TESTING IN A
SIMULATED SPACE ENVIRONMENT.

TECHNICAL REPORT AFML-TR-79-4083

Interim Report for Period October 1976 - September 1977

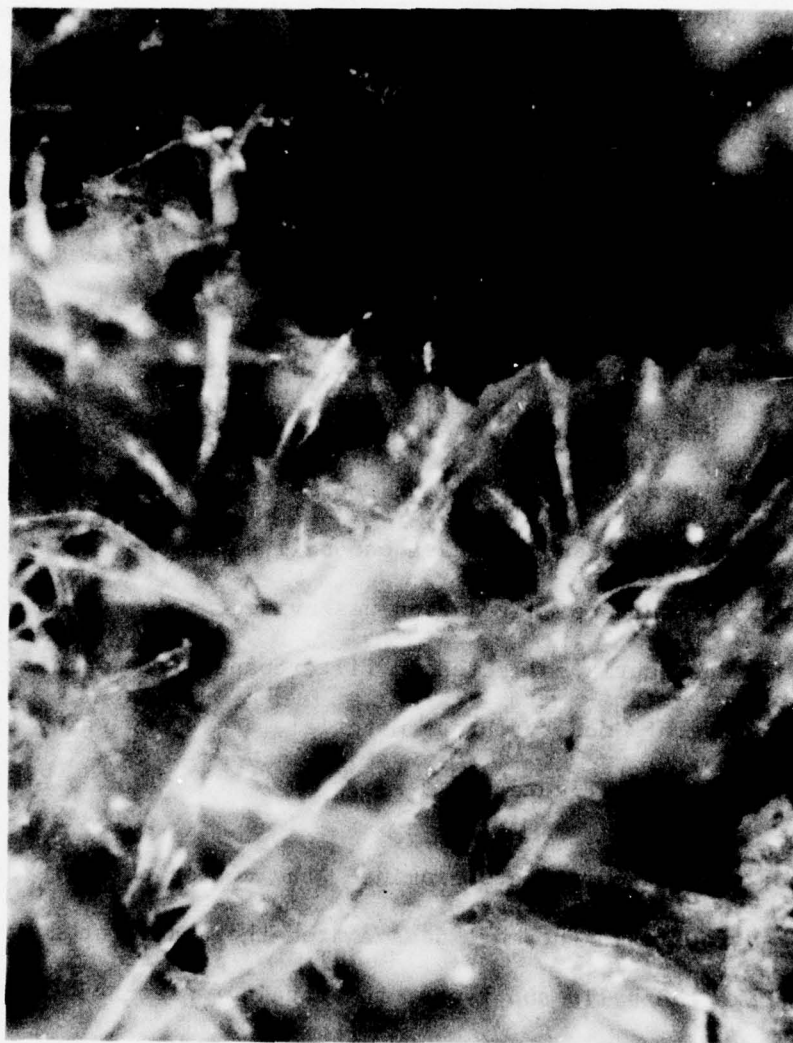
Figure 6. Heptane Wash Residue from Races

As previously mentioned, the balls and races were each pressure rinsed separately with heptane and the rinse solution was filtered leaving debris typified by that in Figures 6 and 9. Among this debris, there was a total of about four shiny metallic looking flakes. Attempts to pick up these flakes with a pointed magnet were unsuccessful. The fact that the flakes were not magnetic suggests that perhaps they were flakes of aluminum foil that found their way into the bearing from packaging. Surprisingly, some pieces of black debris were attracted to the magnet. At this time, it is
